JOINT PHOTOGRAPHIC INTELLIGENCE BRIEF ARMY-NAVY-CIA

SUBJECT : Surface-to-Air Missile Support

Facility

LOCATION: 10 nm NE of Stalingrad, USSR

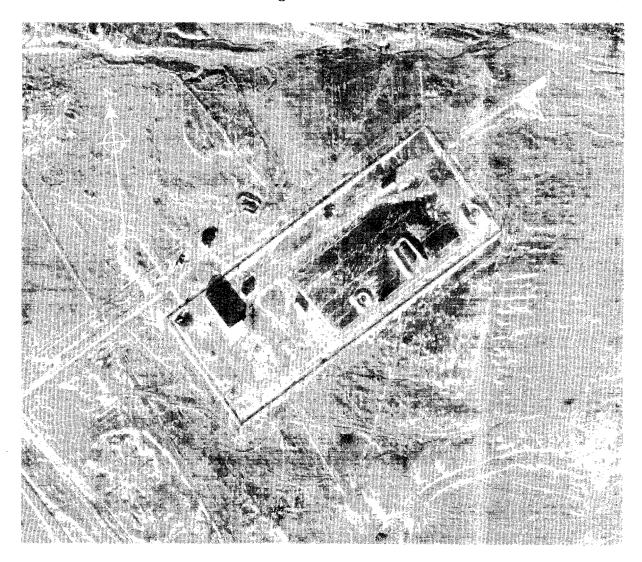
PIC/JB-22/60

Declass Review by NGA? DOD SAM SUPPORT FACILITY 10 NM NE OF STALINGRAD.

This support facility serves SAM sites deployed for the defense of Stalingrad.

Complete and operational.

No vehicles or equipment are visible at the facility.

Three missile trailers are located in an antiaircraft garrison adjacent to the facility.

One microwave tower located adjacent to probable administration building.

Overhead wire line leads to facility.
